Nondestructive Testing As a Tool in the Space Shuttle *Columbia* Accident Investigation

Steven J McDanel
NASA
Kennedy Space Center, Florida, 32899, USA
321.861.8969
321.867.1407
Steve.mcdanels@nasa.gov

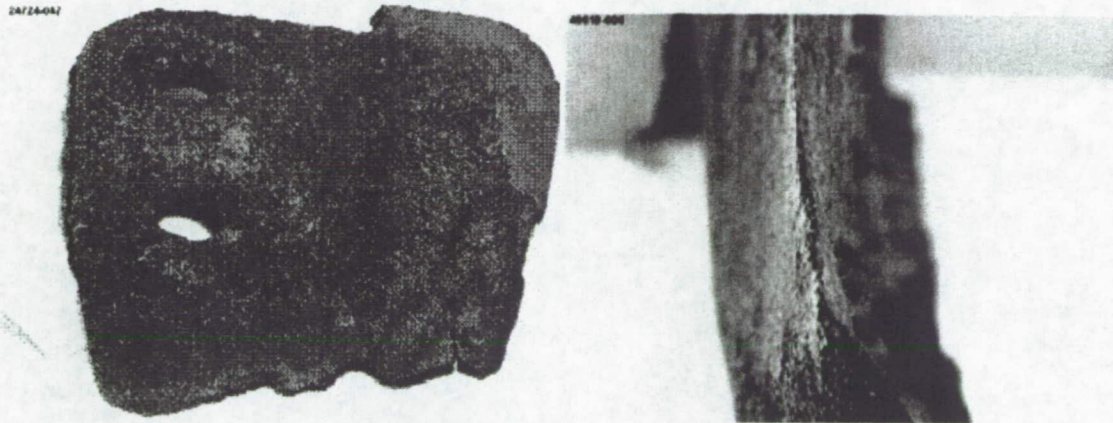
Figure 1

Visual NDT of the debris revealed localized areas of unique damage, such as erosion, excessive heating, and knife edging, as well as mechanical damage (Figure 1). The erosion, heating, and knife edging were results of the extreme re-entry of the *Columbia*; the mechanical fractures generally resulted from either impact with other pieces of debris on descent or impact with the ground.

Visual Examination of *Columbia* Left Wing Leading Edge Panel Piece Showing Evidence of Erosion, Excessive Heating, and Mechanical Damage (right) and Knife Edging (left).

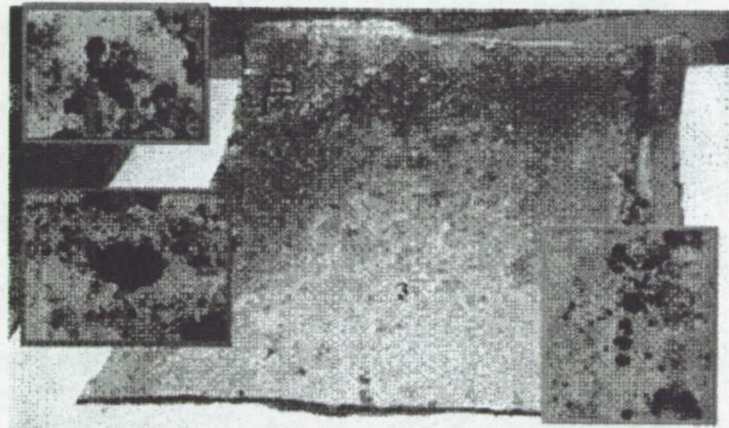
Figure 4

Inverse Radiograph of a Left Hand RCC Upper Apex Displaying Three Distinct Deposition Types and Locations

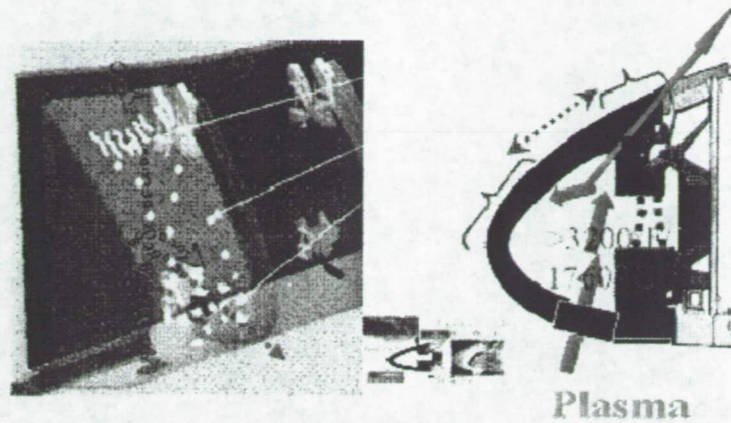
Figure 5

The combination of visual evidence, inverse radiography, virtual reconstruction, and chemical analysis allowed the forensic scientists to verify not only that a breach had occurred in the leading edge of the orbiter's left wing, but also the path the plasma followed (Figure 5), and the sequence of failure events that ultimately led to the loss of the *Columbia*.

Schematic Representation of Events within the Left Wing Leading Edge of the Space Shuttle *Columbia*

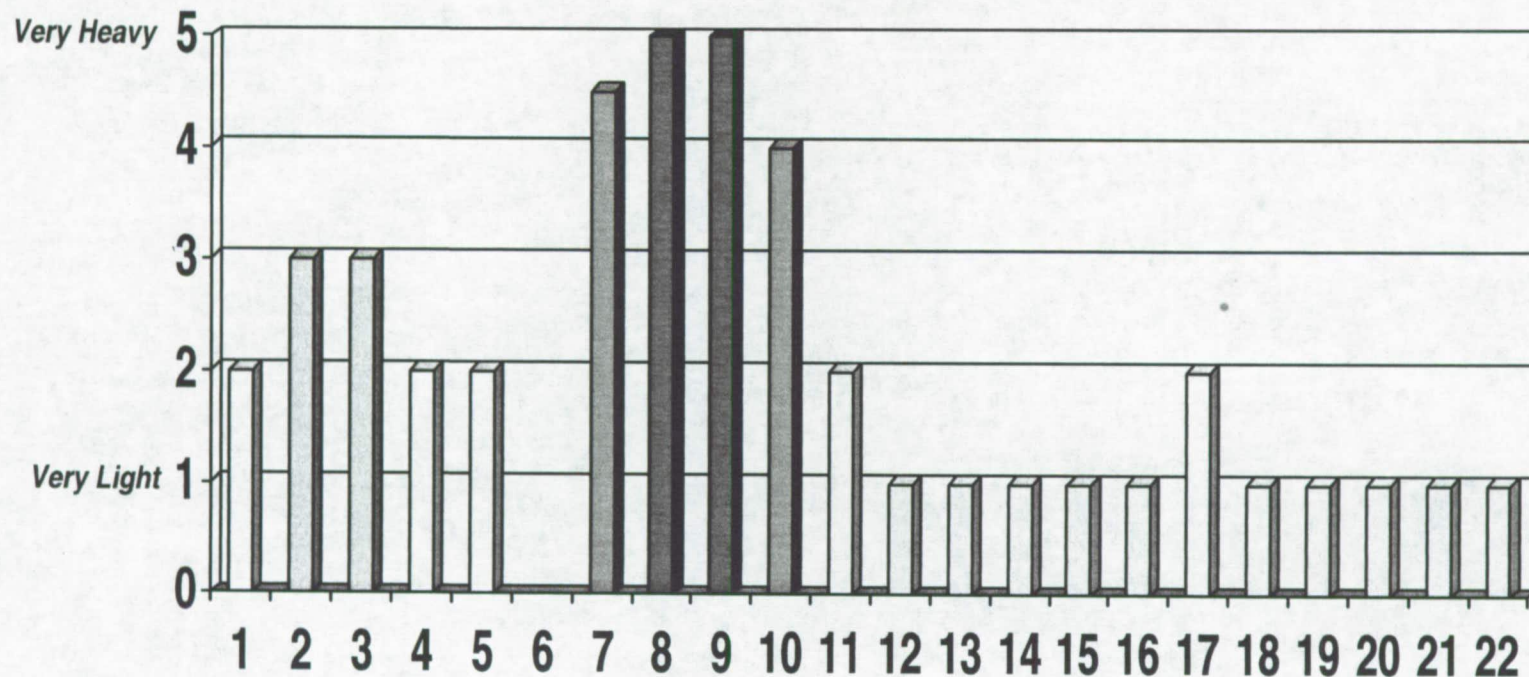
**Distribution of metallic deposition volume
was centered around panels 8 & 9**

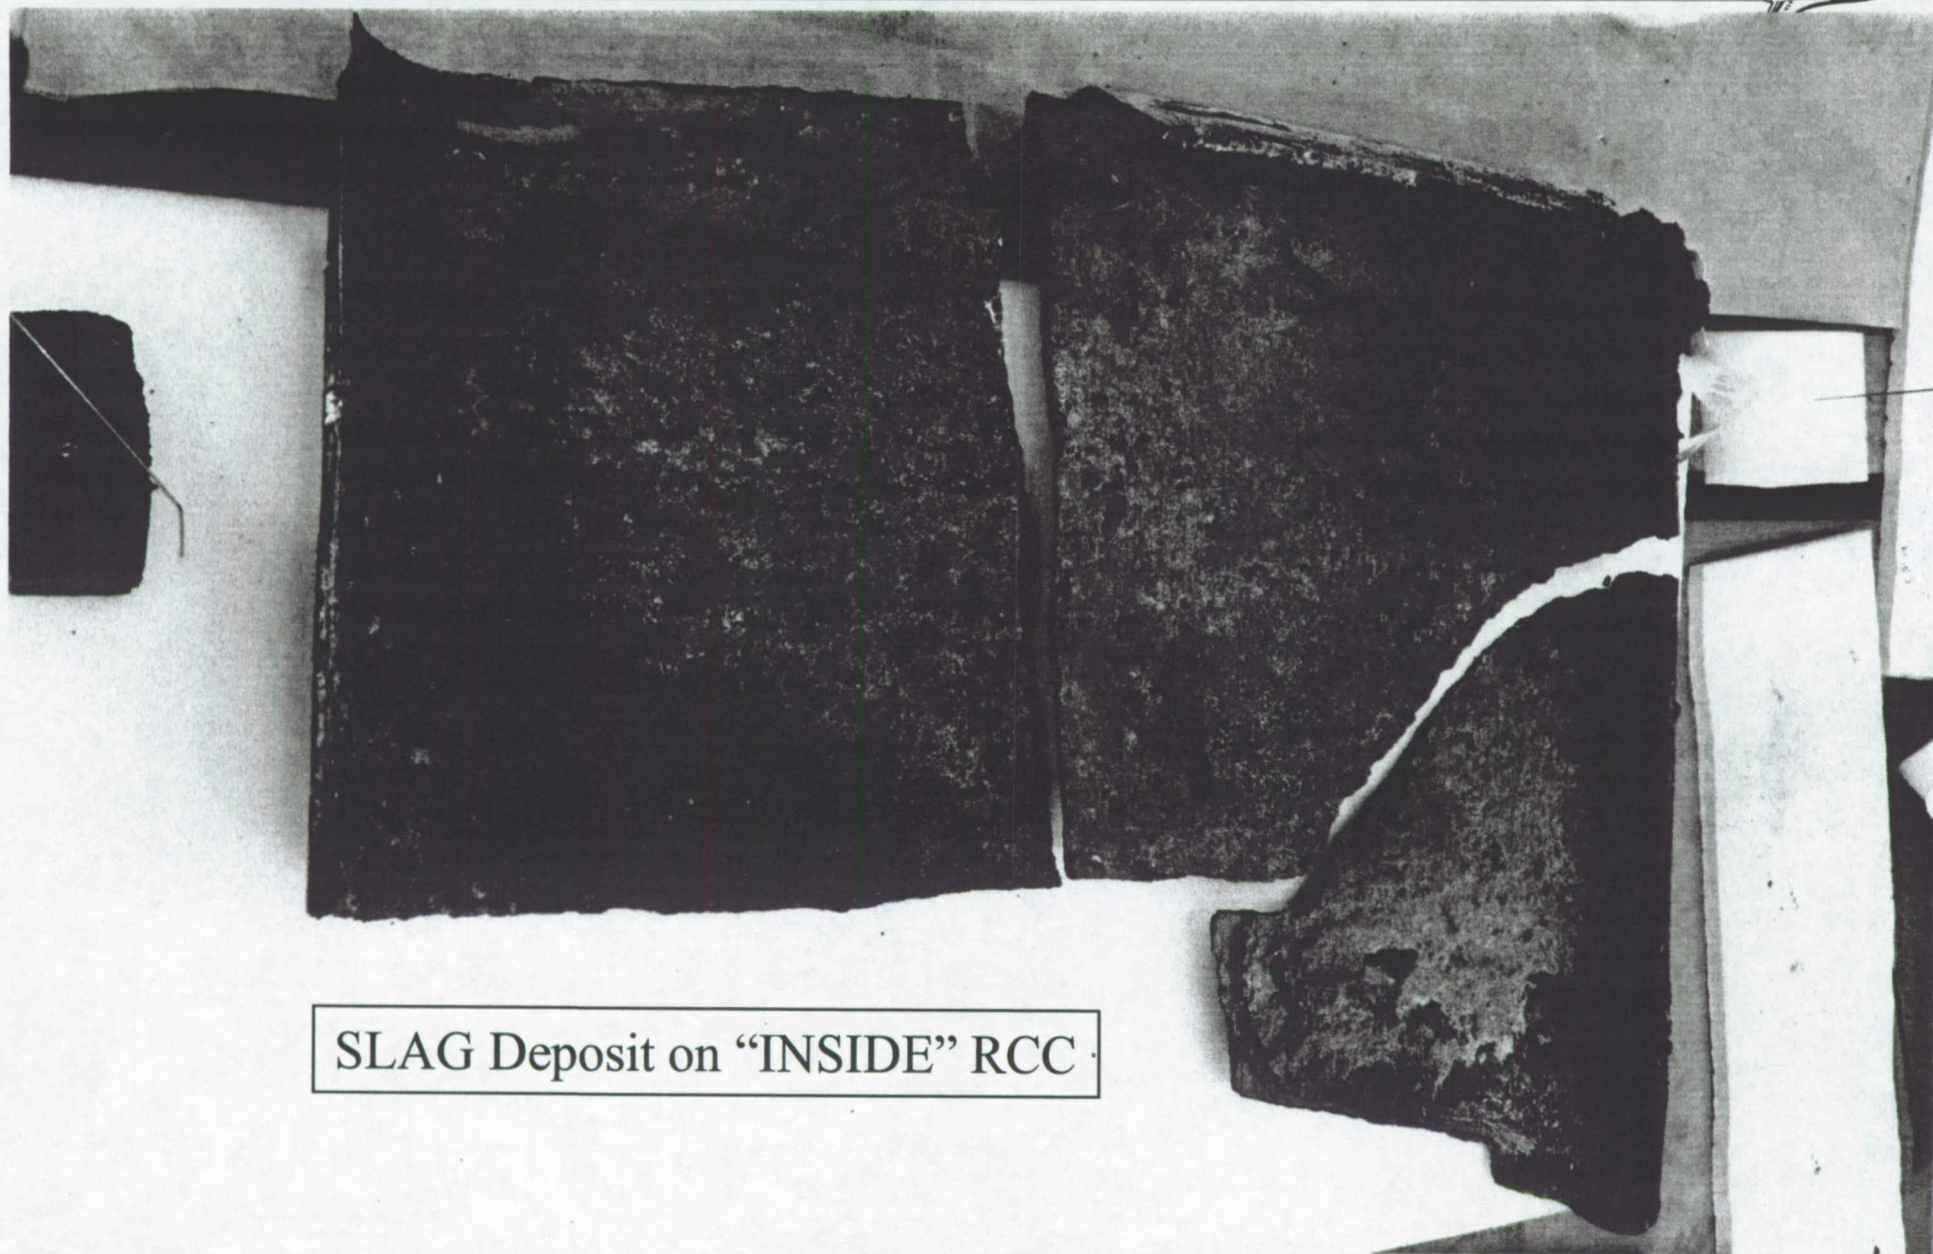
Slag Deposit Example, LH RCC 8

SLAG Deposit on "INSIDE" RCC

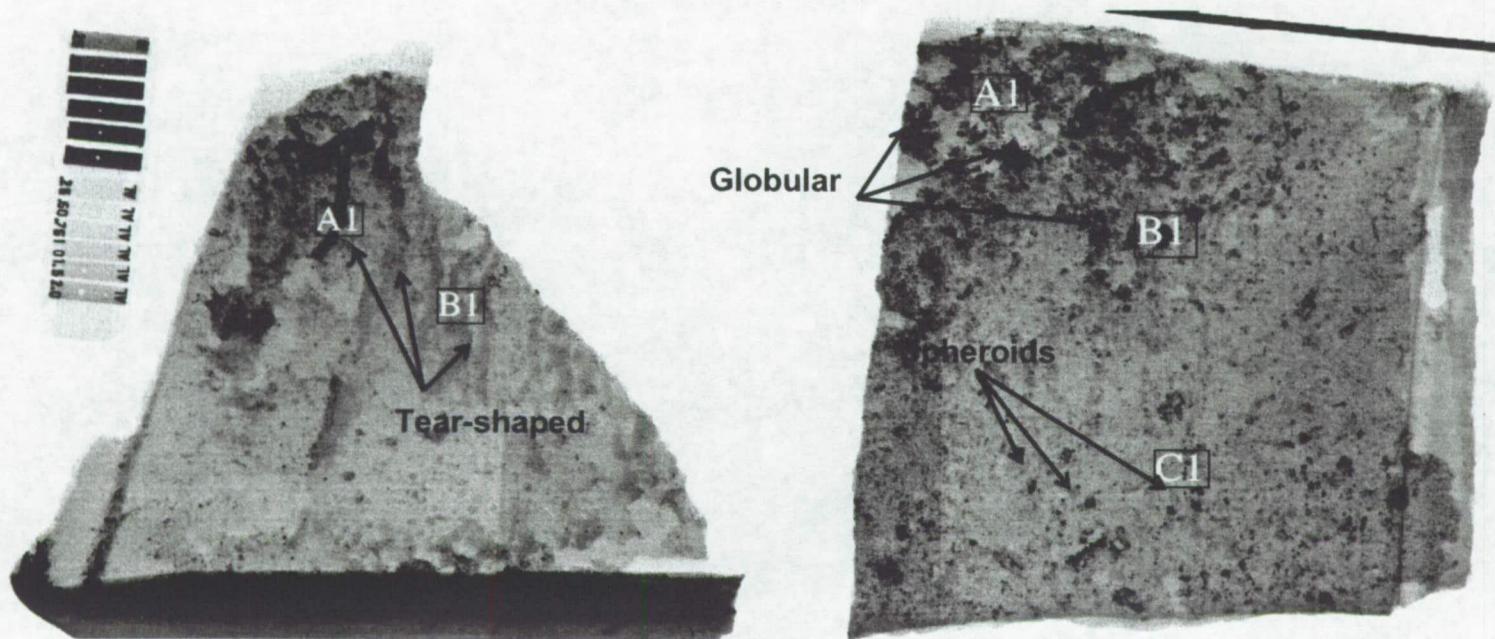
Radiography WLE LH Panel 8

- Four types of deposit patterns were identified from LH RCC Panel 8:
 - ◆ Uniformly thick; Spheroidal; Tear-shaped; Globular

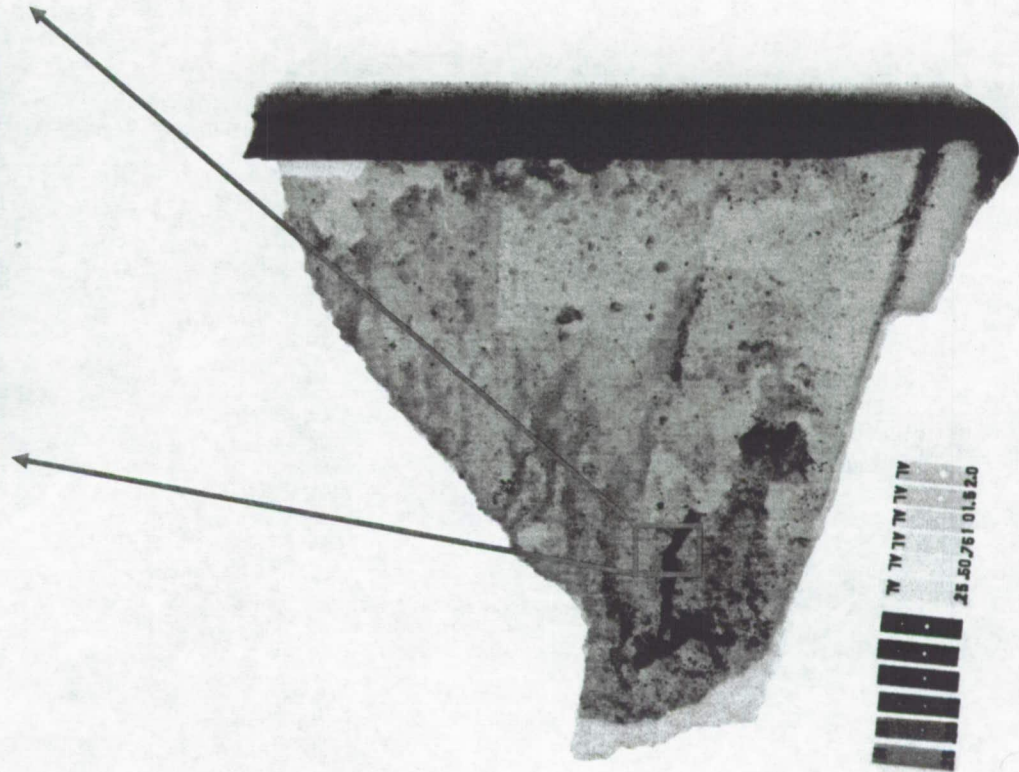
Slag Item 43709, Sample 2A1

LH RCC 8 – Slag Feature: Thick Tear Shaped

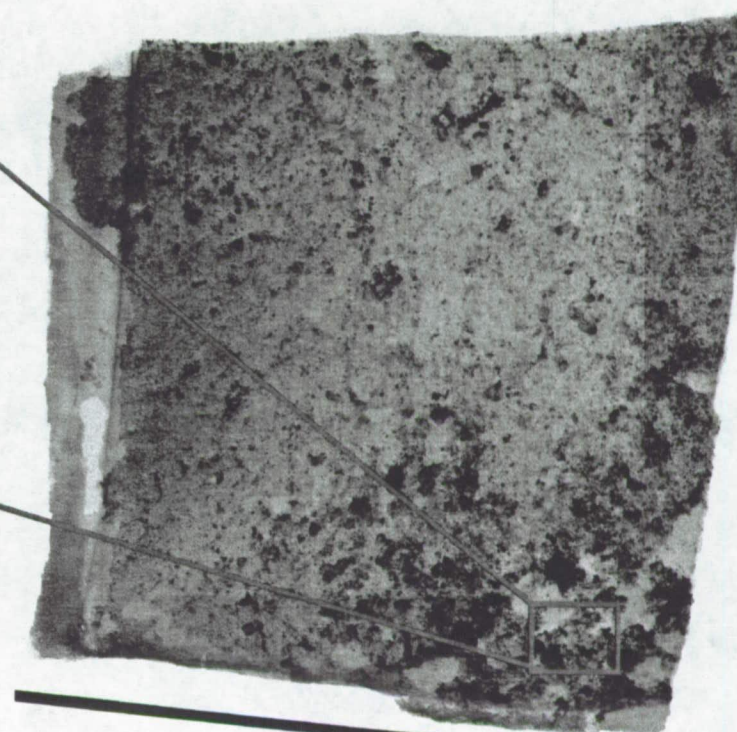
Slag Item 2200, Sample 6A1

LH RCC 8 – Slag Feature: Thick Globules

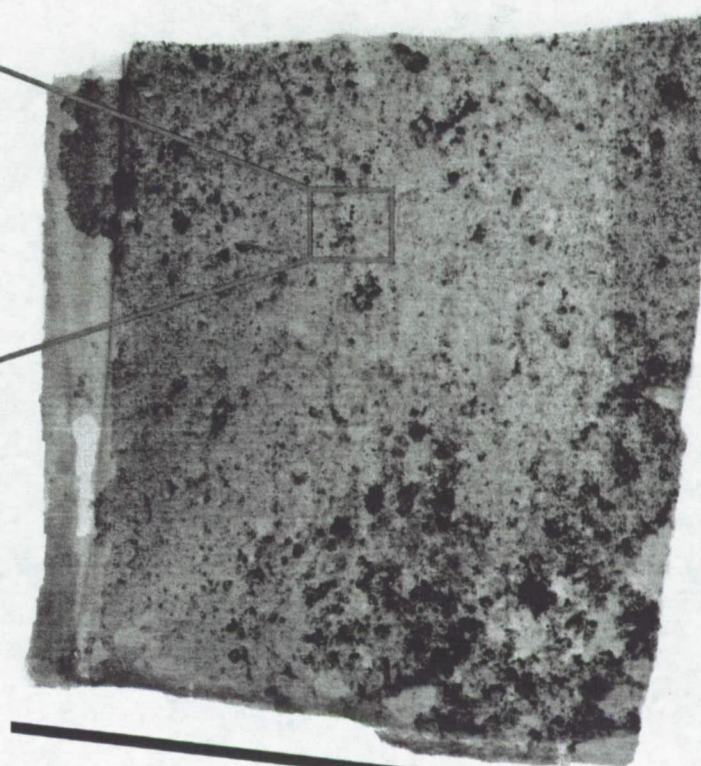
Slag Item 2200, Sample 6C1

LH RCC 8 – Slag Feature: Spheroids

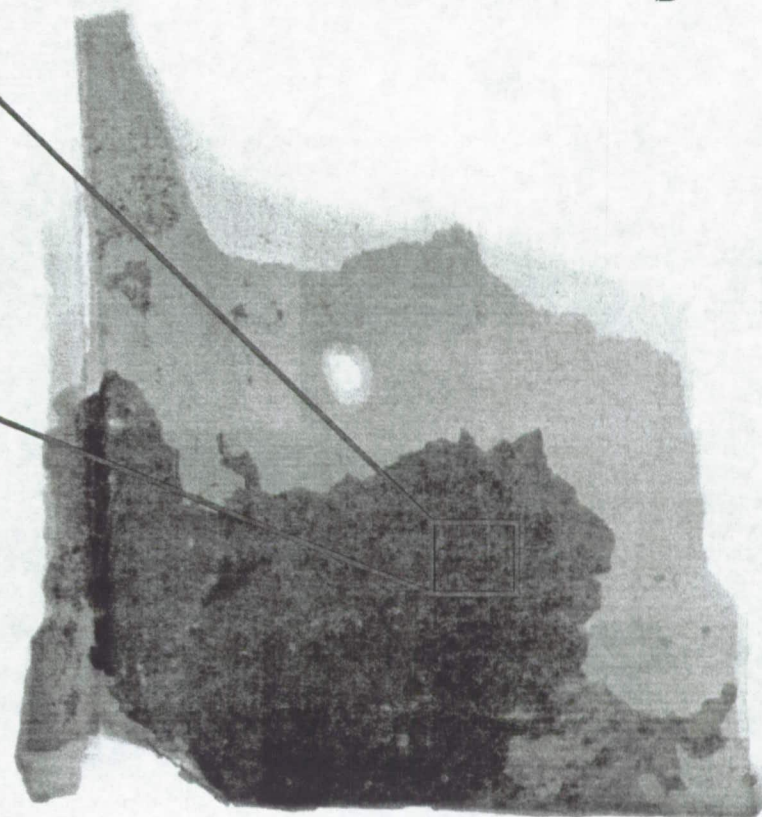
Slag Item 16523, Sample 4A1

LH RCC 8 – Slag Feature: Uniform Deposit

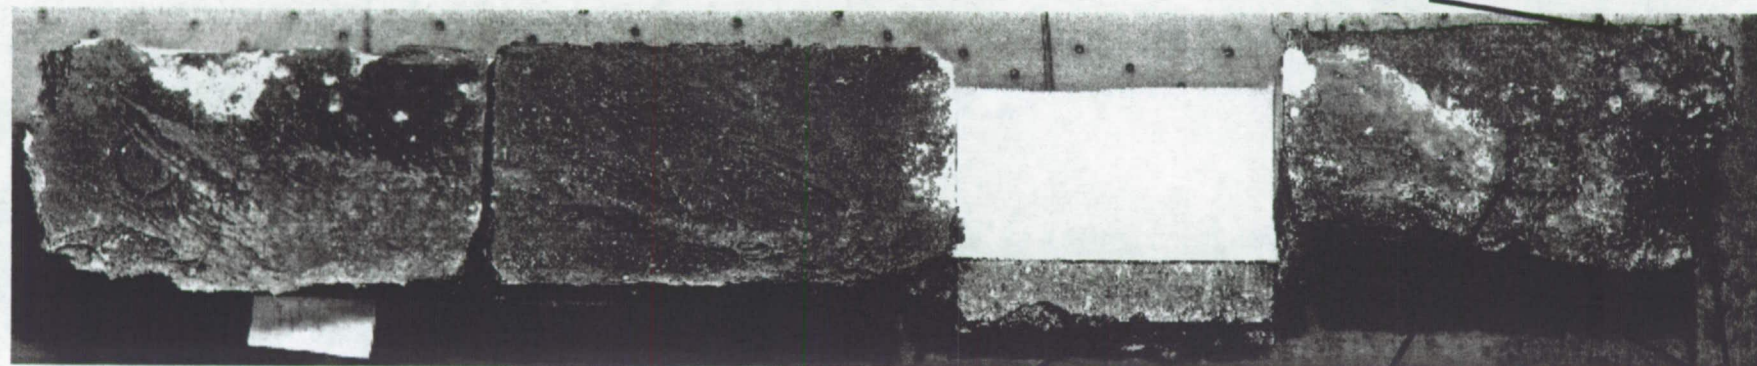
LH RCC Panel 9 Lower CP Tiles

Horse Collar Fabric Deposit

Tile Slumping

Molten Slag on Tile

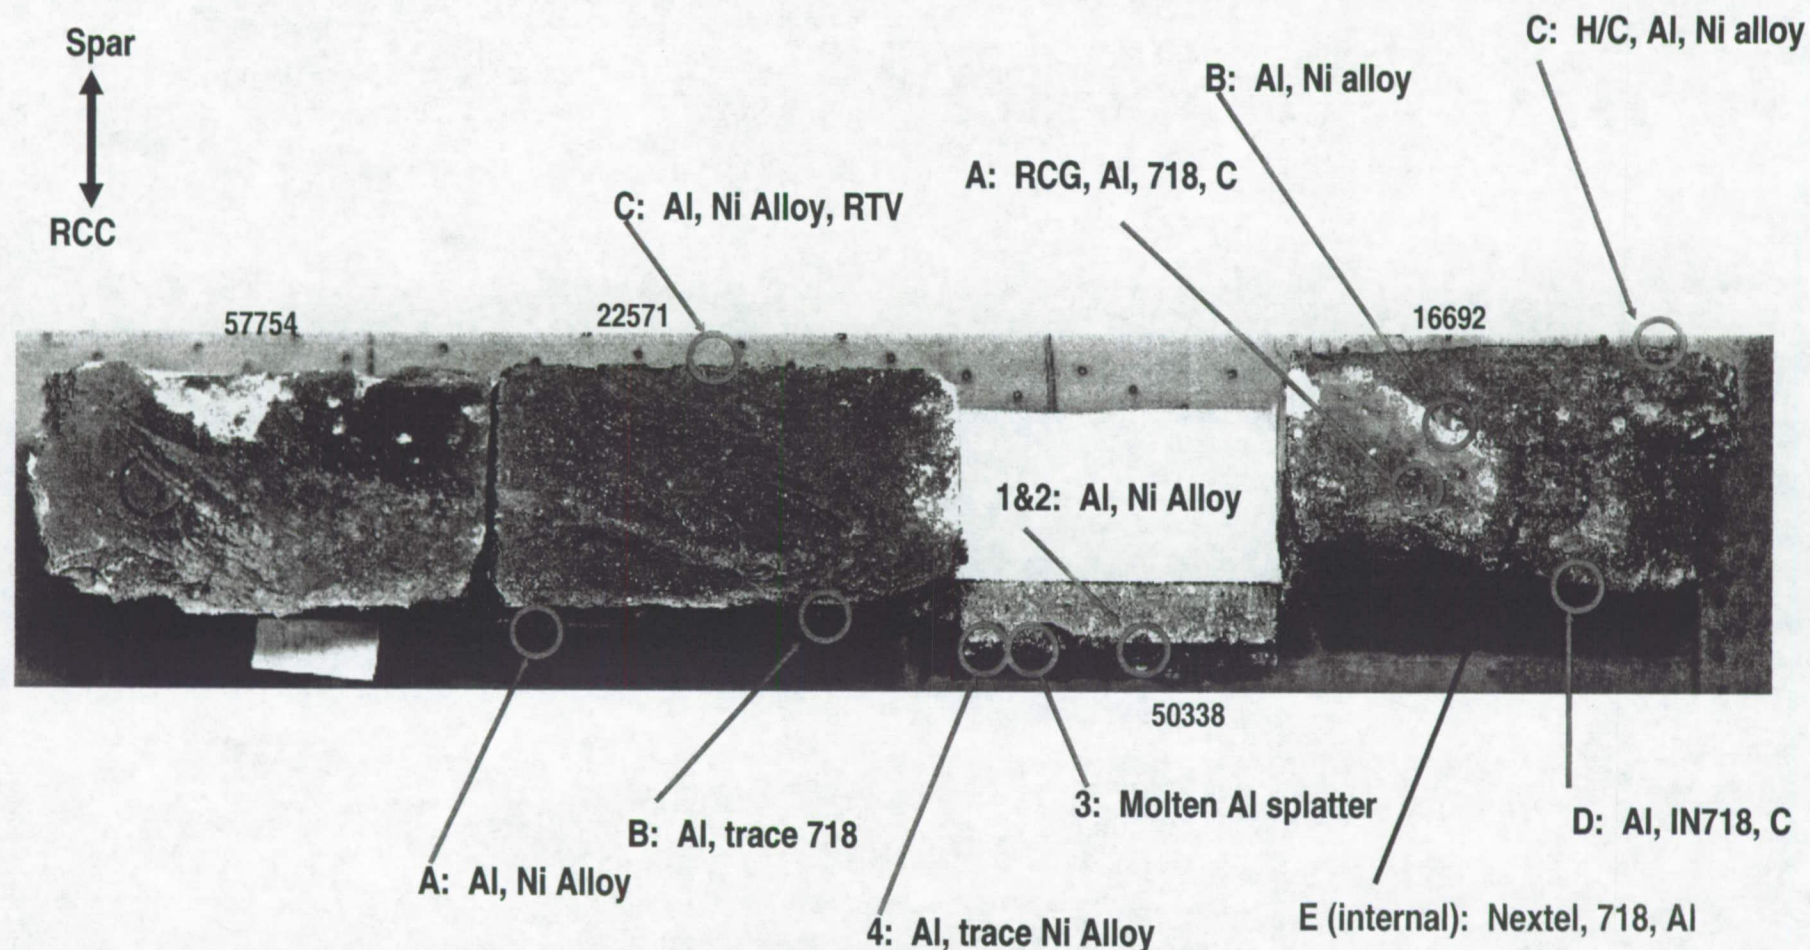
Sampling – LH Panel 9 Lower CP Tiles

These findings suggest flow of material from inside the RCC out through the upper and lower CP locations.

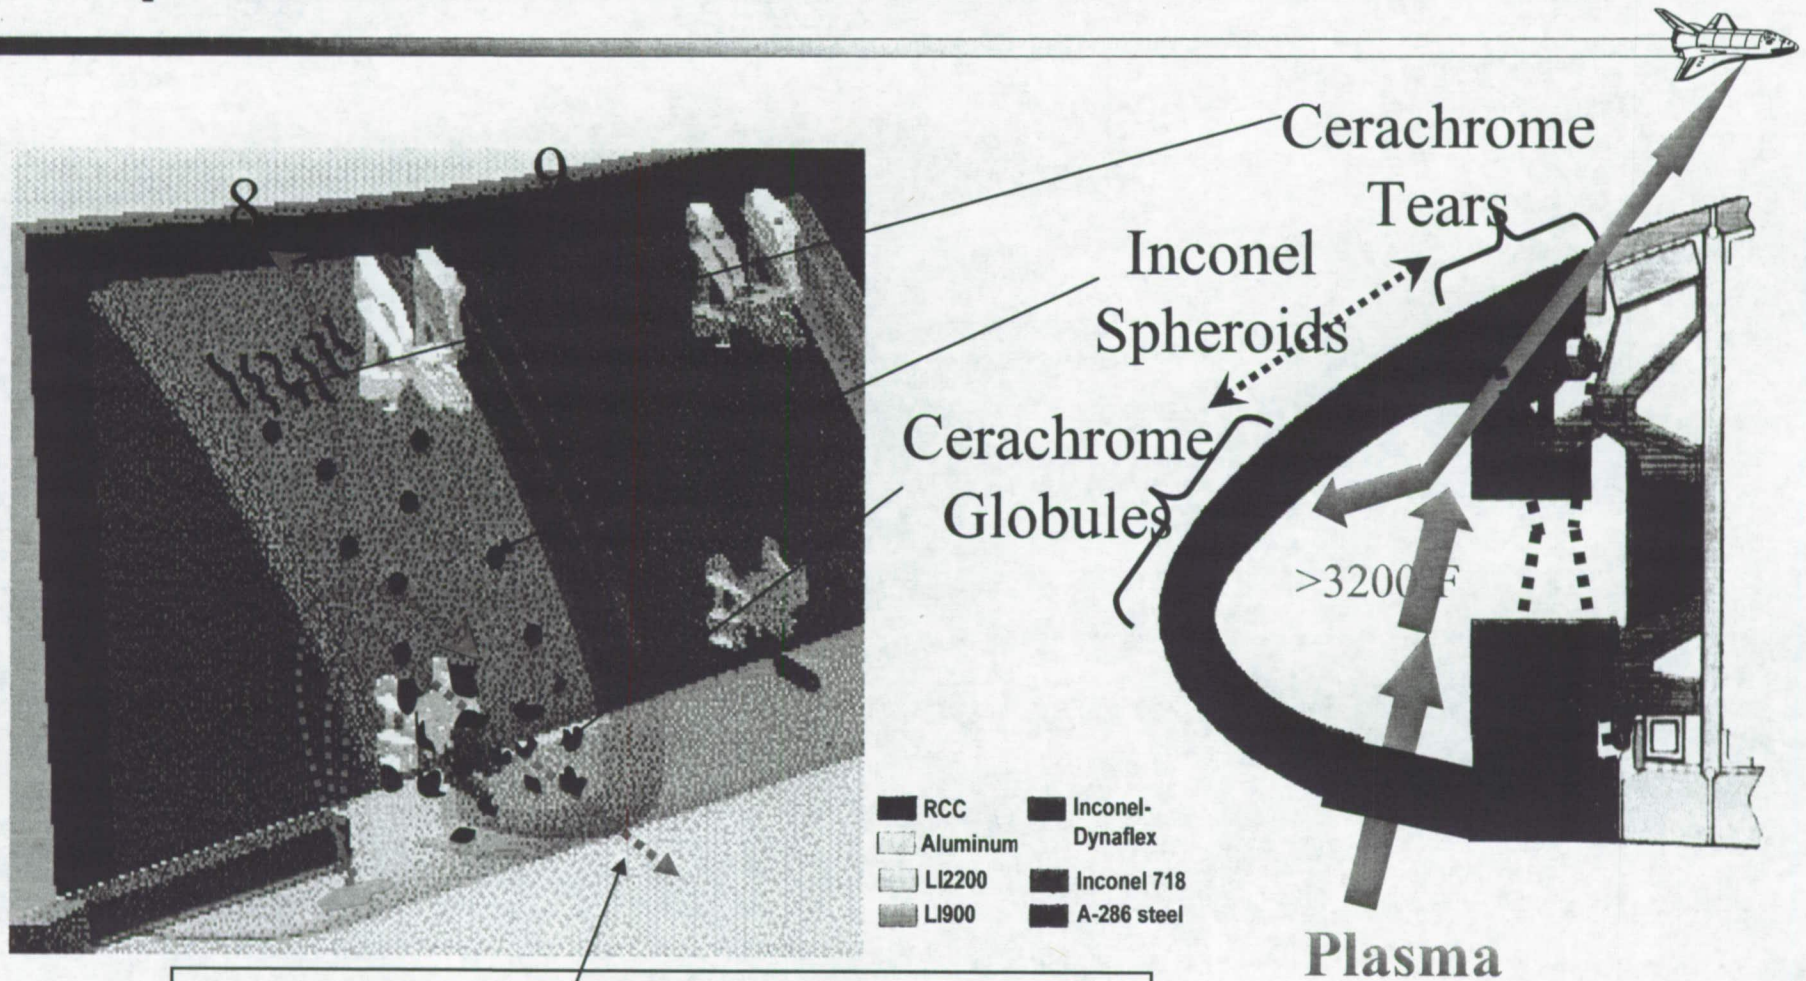
Proposed Breach Location and Plasma Flow

Flow Exiting through RCC 8 on to lower Carrier Panel 9 tiles

- Overall forensic assessment is consistent with M&P Team conclusions
- All forensic evidence suggests a breach occurred on the lower surface of the LH RCC panel 8, close to the T-seal with panel 9
- The breach was present early during reentry allowing the ingestion of hot gasses into the wing leading edge cavity, which continued for several minutes prior to vehicle breakup
- Sequence of events:
 - ♦ Melting and vaporizing the Inconel 601 foil-covered cerachrome insulation blankets
 - ♦ Slumping the wing carrier panel tile immediately aft of the breach
 - ♦ Eroding the RCC adjacent to, and downstream of, the breach
 - ♦ Melting and/or weakening the Inconel 718 and A286 leading edge attach hardware
 - ♦ Destroying the nearby instrumentation and wire bundles
 - ♦ Penetrating the aluminum wing leading edge spar
